Trouble Shooting Banding

Service Bulletin

8/27/2007

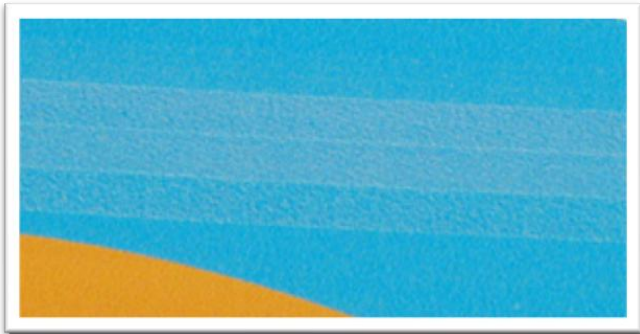
This is a sample of a type of banding that is being caused by drop out or the failure of the head to fire. The head could be dirty and need cleaning, the dampers or manifold may be failing or possibly the head has exceeded its lifespan and needs to be replaced.

5. Check condition of the wipers. Heads that are not properly cleaned will have ink build up which can wick across the head and cause drop out which creates banding.

6. Perform a thorough manual cleaning of the print heads, cap tops, wipers, wiper scraper and serge mist filter. Replace consumable parts that appear worn.

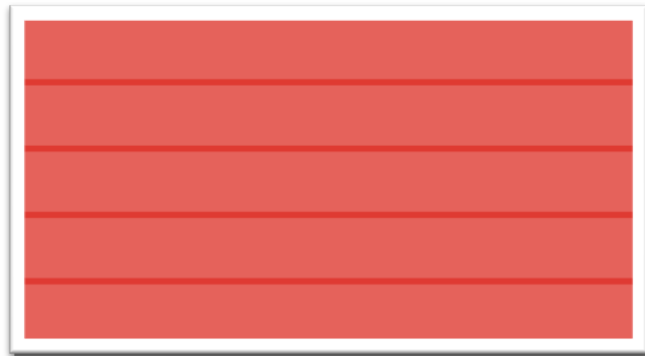
Banding such as this is an indication that the media feed calibration is not set properly. In an instance such as this the feed calibration would need to be increased to bring the print passes apart to remove the overlap.

4. Make sure the proper media feed calibration is set and that it is not being overwritten by the RIP software. Also check to insure that media is feeding properly from the roll, the media flanges are being used and that the roll does not exceed the specified weight limit for the machine. Using the Prefeed option on the machine helps to isolate a situation where there is a feeding issue.

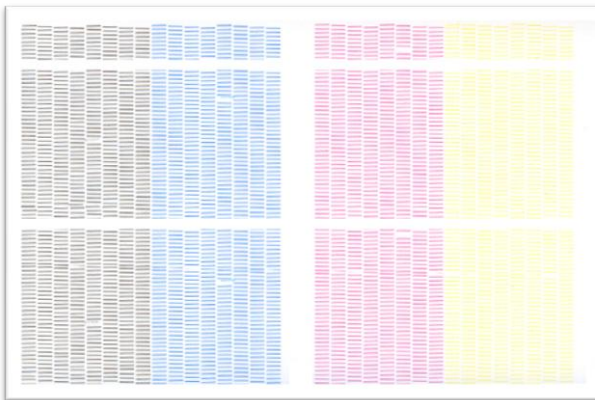
2. Print a Service and History report and look for the shot counts on the print heads (any over 5 billion shots have exceeded their life and may be suspect) and servo errors to indicate head strikes which can damage print heads. The sample below shows a nozzle test pattern which indicates print head damage from a head strike. Notice the two horizontal lines which run

completely through the print area. These will cause banding and can not be repaired. A quick visual inspection of the print heads will confirm the damage. Look for the surface area of the print head to be scratched or dented. Print heads with this type of damage must be replaced and are not covered under warranty due to misuse by the end user.

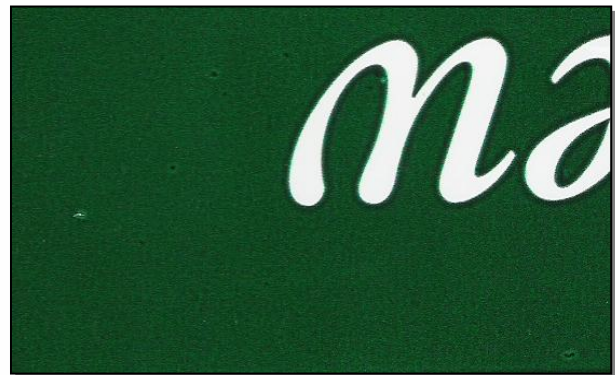
7. Check that heater settings are correct and that the heater voltage switches on the underside of an SP series machine are set properly. The image to the right shows a heater setting that is too low, causing an "orange peel" effect. The image to the left shows a heater setting that is set too high can cause a lighter banding effect. The additional heat causes dot

gain to be reduced which means the ink to dries quicker than expected leaving white areas from where the droplets should have spread out before drying.
